Geoguide

Traces of Pyroclastic Flow in Aso and Columnar Joints

This is a product of nature's blessing and people's wishes

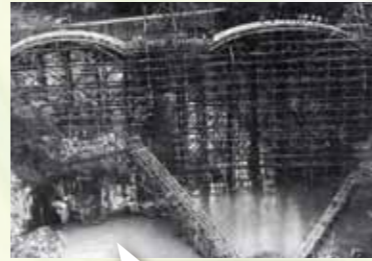
Todoro Bridge when under construction. This clearly shows how they made the arch.

The Todoro Bridge was constructed in 1934 by the local forestry office as a part of the railway that was laid to carry logs from Mt. Katamuki on the Okudake River. The bridge had to be large and sturdy to support the rail and train. The arch on the right bank measures 32.1 meters and the arch on the left is 26.2 meters. The distance between the water surface and girder is 27 meters. Both the Deai and Todoro bridges were built completely of Aso ignimbrite.

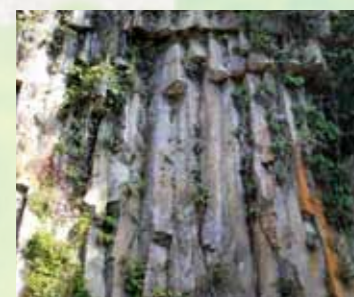
Pyroclastic flow consists of a huge amount of very hot volcanic gas, lava, pumice stone, and volcanic ash at temperatures as high as 300 to 700 degrees centigrade that flows rapidly down the sides of the volcano reaching speeds of more than 100km/h. The accumulated deposits continued to melt in the extreme heat but eventually began to cool. During the cooling process, vertical cracks appeared in the rock due to contraction and came to look like bundles of pencils. These cracks are called columnar joints.

It looks like a curtain. It is amazing to know that this was created naturally.
